ESL-TR-85-65

RAPID RUNWAY REPAIR (RRR) IN-HOUSE TEST AND EVALUATION

FINAL REPORT

ENGINEERING & SERVICES LABORATORY
AIR FORCE ENGINEERING & SERVICES CENTER
TYNDALL AIR FORCE BASE, FLORIDA 32403

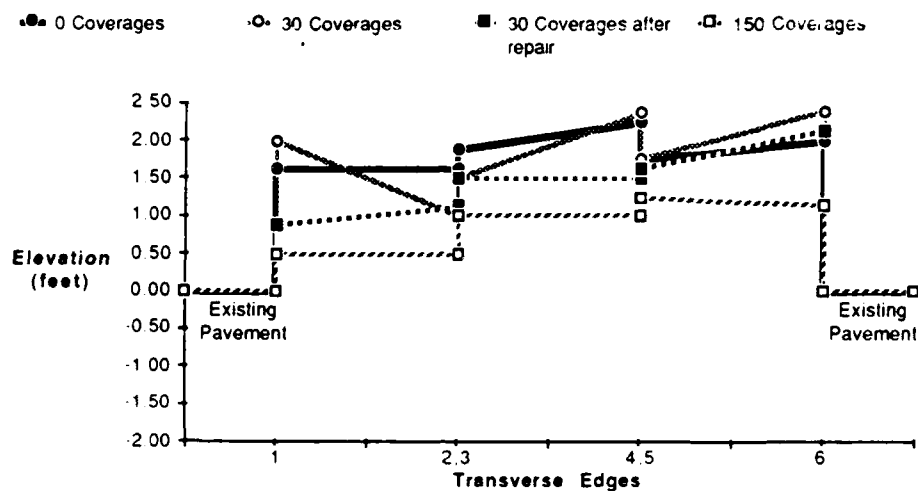
The test resulted in early settlement under traffic loads. This may be reduced by using more and better material on top of the debris back-

Figure 22. Slab Elevation Profiles Along Longitudinal Edge A, Preliminary Test.
